SENECA FALLS DAM

PHASE I INSPECTION REPORT NATIONAL DAM SAFETY PROGRAM

NY 00708

Prepared by: O'Brien and Gere Engineers, Inc.

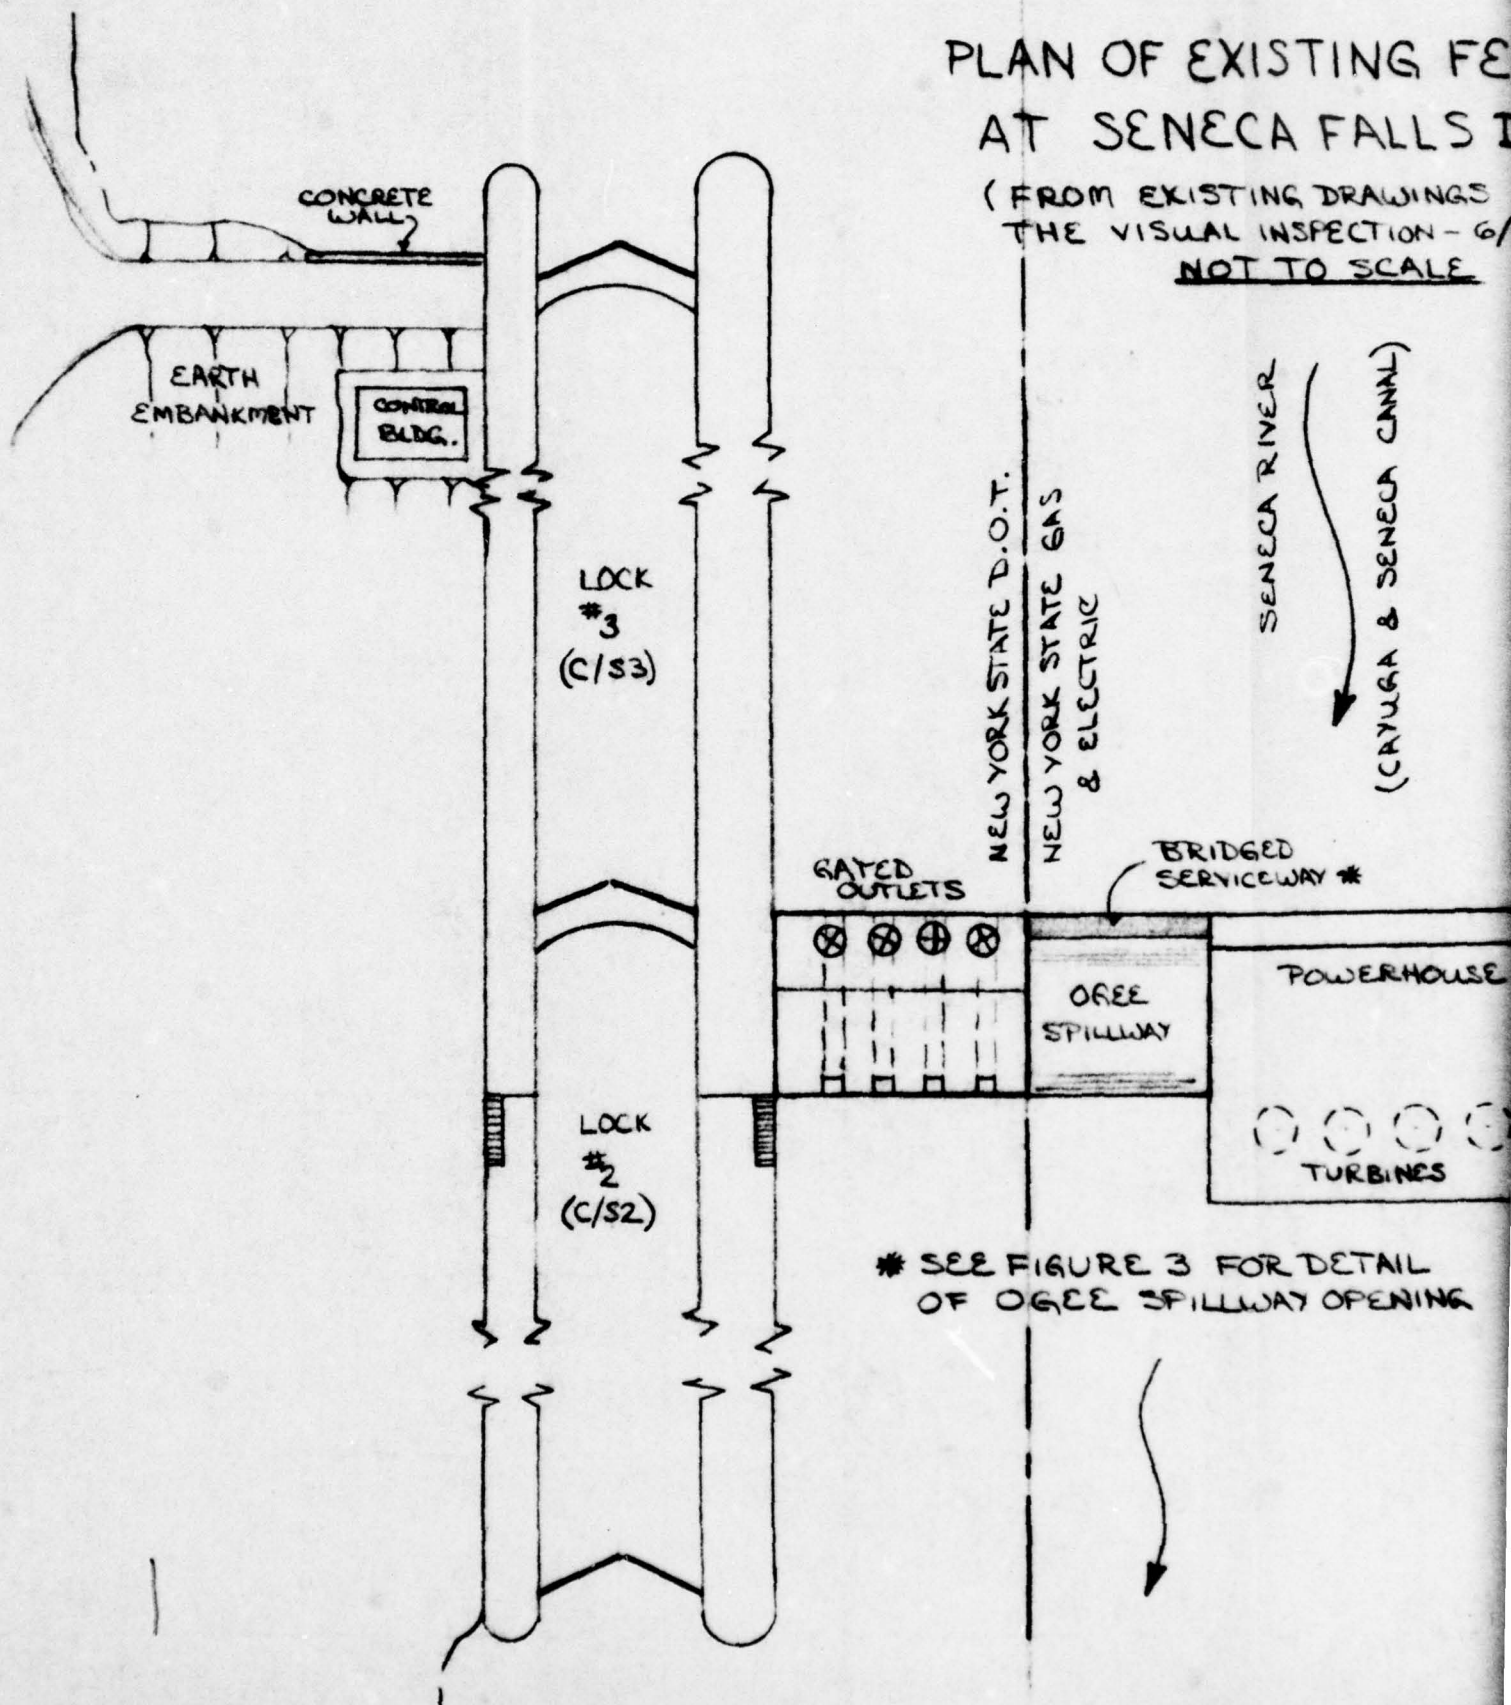
PLAN OF EXISTING FEATURES AT SENECA FALLS DAM

The dam is an integrated, concrete gravity and earth embankment structure (See Figure 2) including:

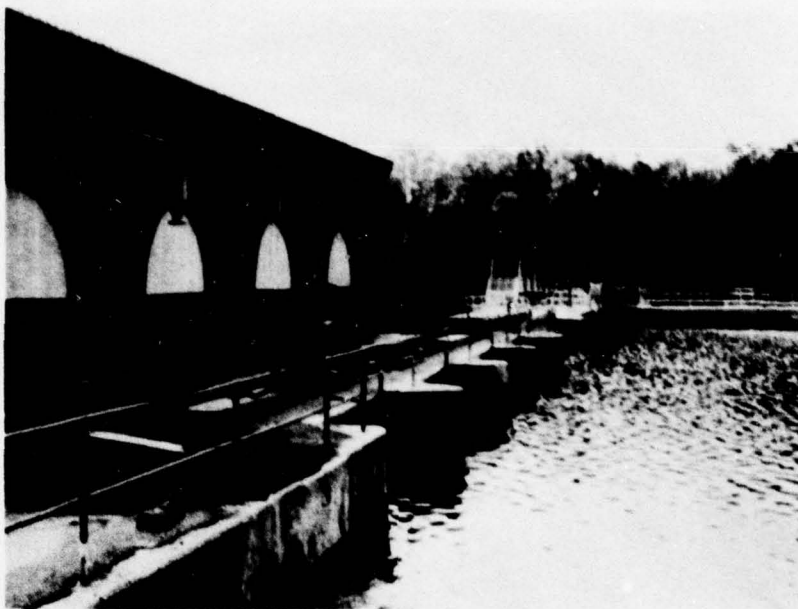
UPSTREAM FACE OF DAM FROM NORTH EMBANKMENT

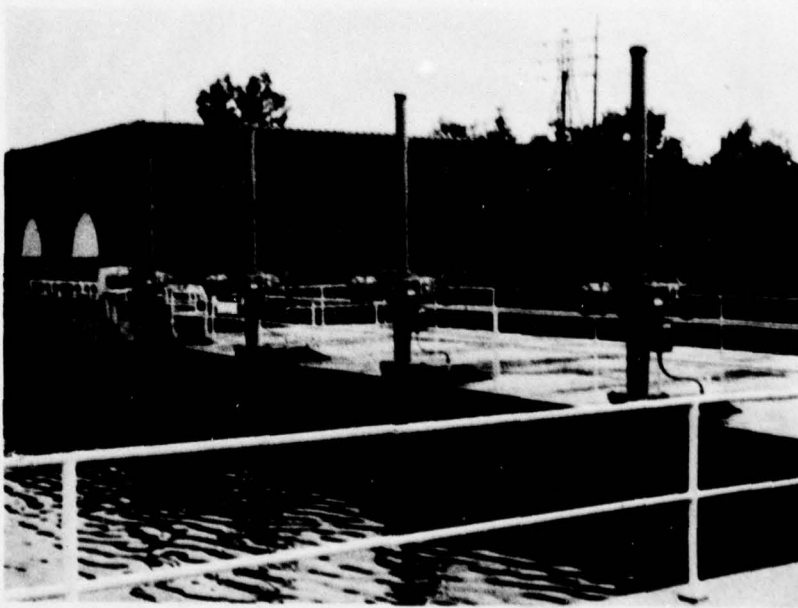
GATE OPERATING ASSEMBLIES AND POWERHOUSE

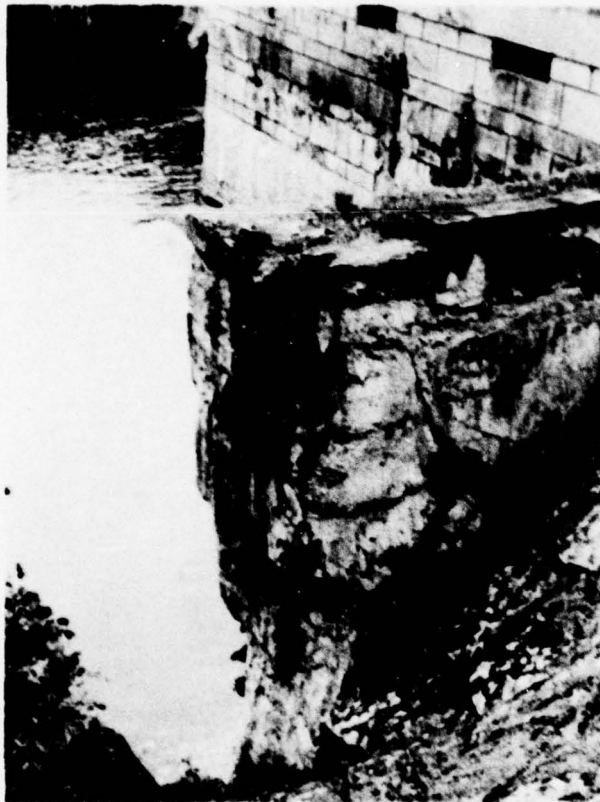
The powerhouse is a massive concrete structure with a brick superstructure. A walkway at the upstream side of the powerhouse appears to have been resurfaced with macadam recently. The concrete trash rack supports have also been recently resurfaced. A concrete retaining wall extends about 75 feet downstream of the powerhouse. The wall is badly spalled and cracked, especially at the downstream end. Weep holes were observed in the retaining wall about midway from the powerhouse to the end of the wall. About one gallon per minute of clear water was discharging from a weep hole at the base of the wall. The weep holes at about 15 feet and at about 30 feet above the tailwater pool were dry.

POWERHOUSE
RETAINING WALL

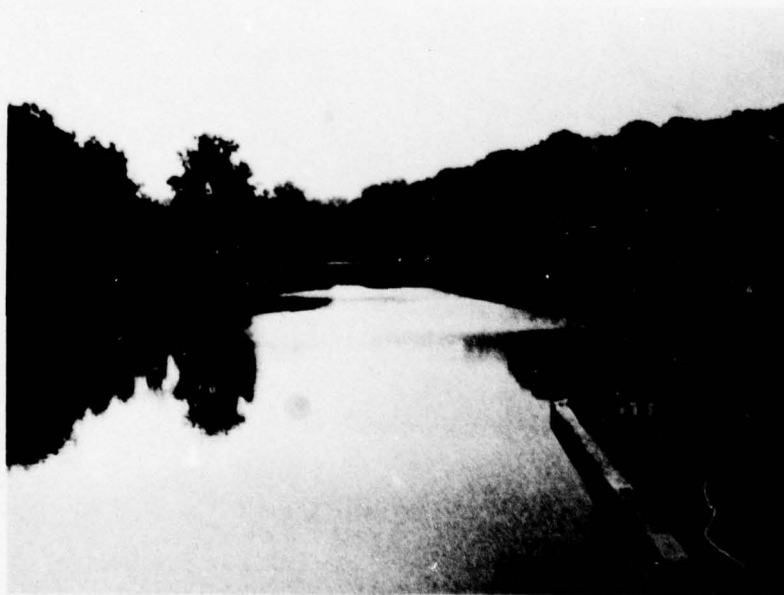
DOWNSTREAM CHANNEL

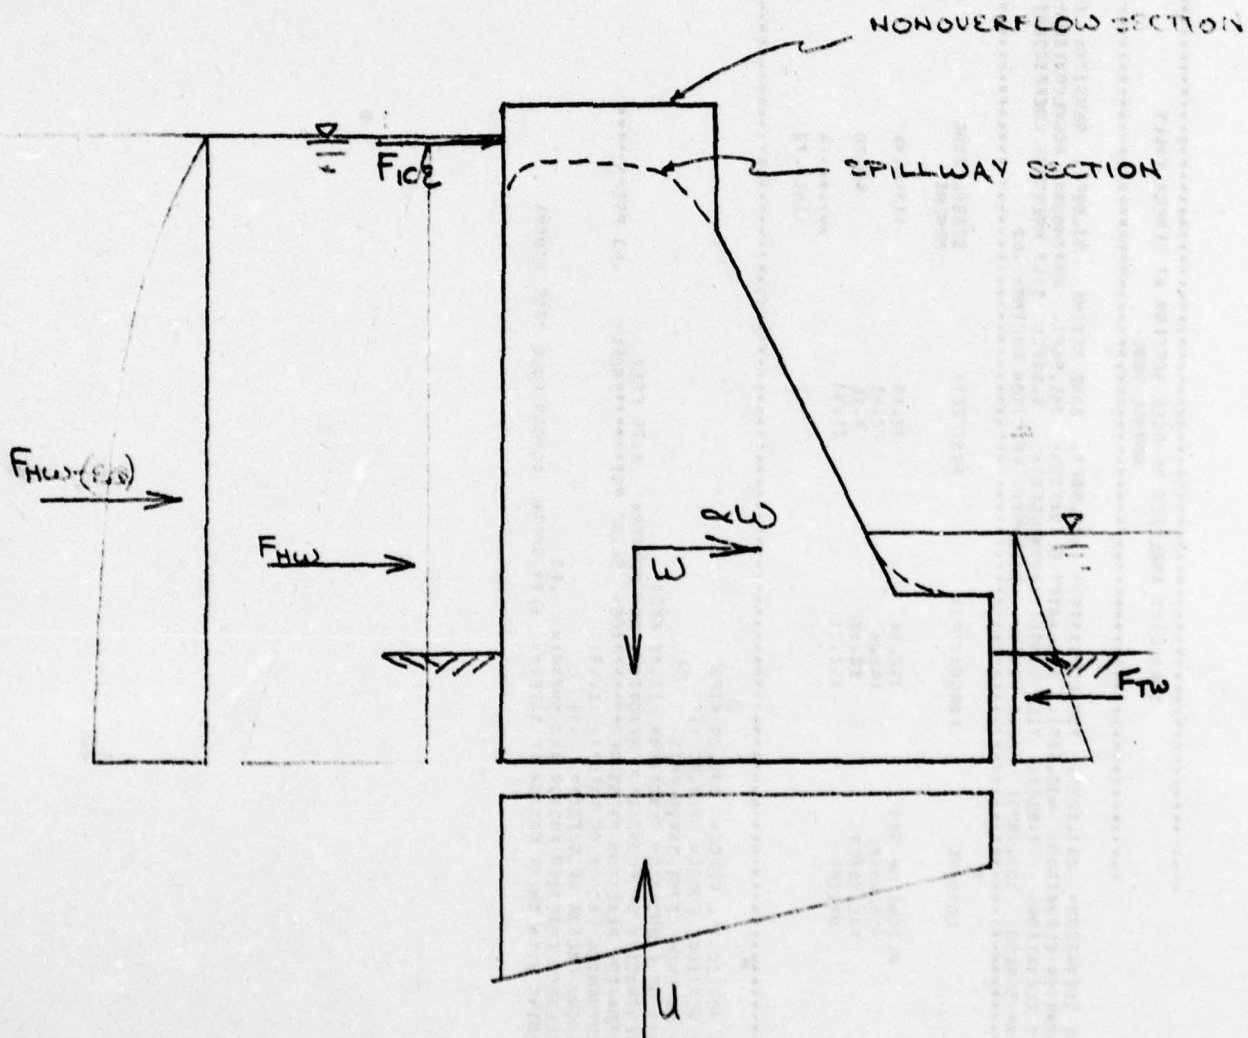
STABILITY ANALYSIS OF OGEE SECTION AT SENECA FALLS
NORMAL POOL

Review of the stability analysis for the spillway section indicated that satisfactory factors of safety are present only for the normal pool condition. Higher pool elevations and ice loading conditions cause the resultant of forces to fall outside the middle third of the base.

*****FOUNDATION REACTION NOT IN CENTRAL THIRD OF BASE*****TENSION AT WHEEL OF DAM*****
 *****HEEL*****HEEL= -9.34 PSI*****
